# CCTV VIDEO REVIEW AND MANHOLE CONDITION ASSESSMENT

City of Los Altos

November 2009

**City of Los Altos  
CCTV VIDEO REVIEW AND  
MANHOLE CONDITION ASSESSMENT**

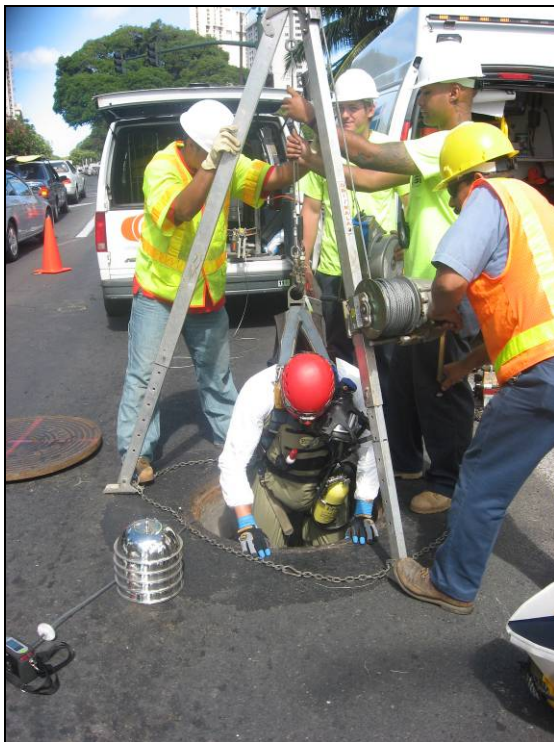
Photo 3.1 – Confined Space Entry

A confined space (Photo 3.1) is defined as any space that is large enough and so configured that a person can bodily enter and perform assigned work, has limited or restricted means for entry or exit, and is not designed for continuous employee occupancy. Title 8, Section 5158 of the California Code of Regulations provides the guidelines and rules for working in these environments. In general, the atmosphere must be constantly monitored for sufficient levels of oxygen (19.5 to 23.0%), and the absence of hydrogen sulfide ( $H_2S$ ) gas, carbon monoxide (CO) gas and lower explosive limit (LEL) levels. A typical confined space entry crew has at least three members: the entrant, the attendant and the supervisor. The entrant is the individual who will be performing the work. The entrant is equipped with personal protective equipment needed to perform the job safely, including a personal 4-gas monitor (Photo 3.2). If it is not possible to maintain line-of-sight with the entrant, then more entrants are required until line-of-sight can be maintained. The attendant is responsible for maintaining contact with the entrant(s) to monitor the atmosphere on another 4-gas monitor and maintaining records of all entrants, if there is more than one. The supervisor develops the safe work plan for the job at hand.
